IAH-NSW Presentation Oct 08

Monitoring Depth of Soil Cracking in Irrigated Fields

AK Greve, RI Acworth, BFJ Kelly
October 2008

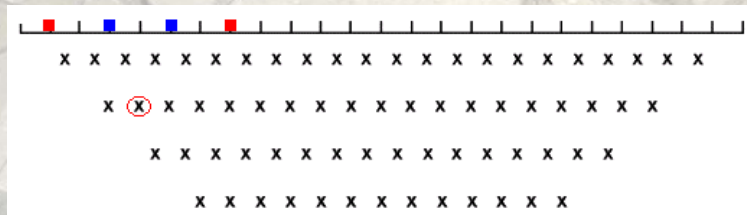
Electrical Resistivity Imaging:

- 4 electrodes, 2 for current flow & 2 for potential measurements → Resistivity

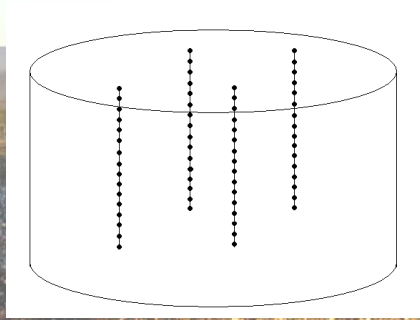
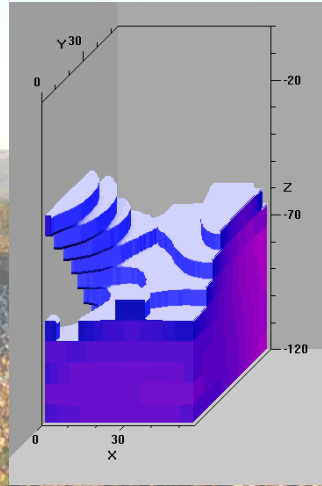
3D Resistivity tomography around crop roots:

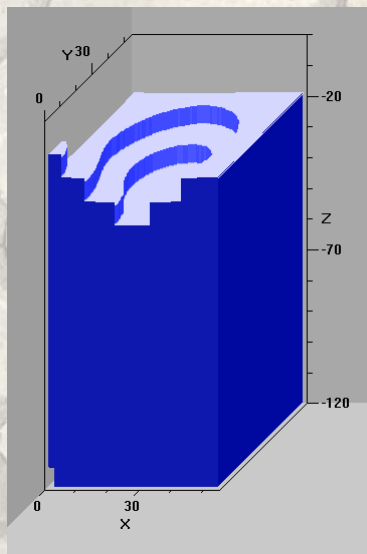
Flood irrigation of cracked soil:

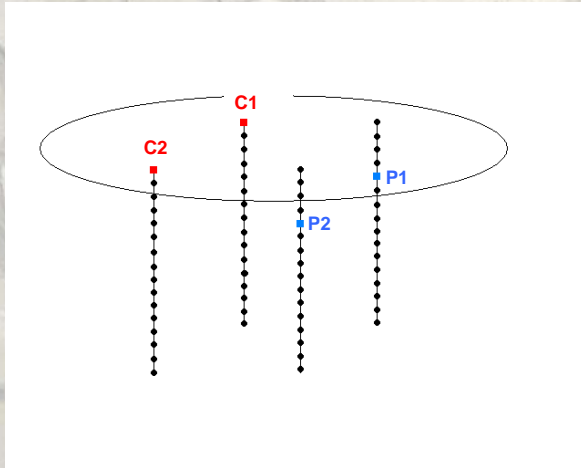
Apparent Anisotropy Index (AAI):

$$AAI = \frac{\rho_a A}{\rho_a B}$$

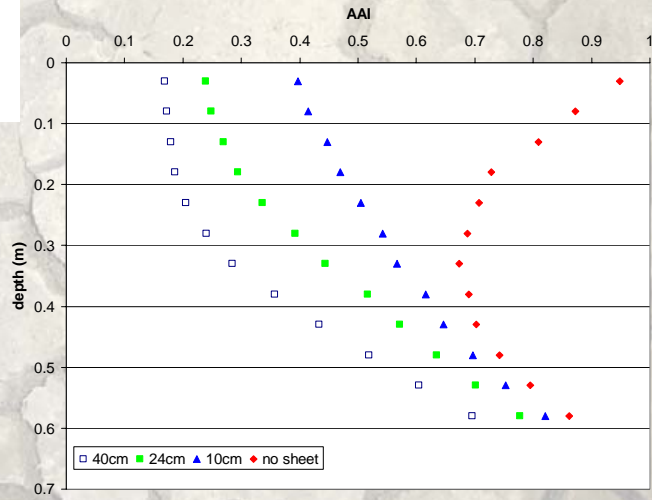
Sand filled lysimeter – sheet in entire plane:

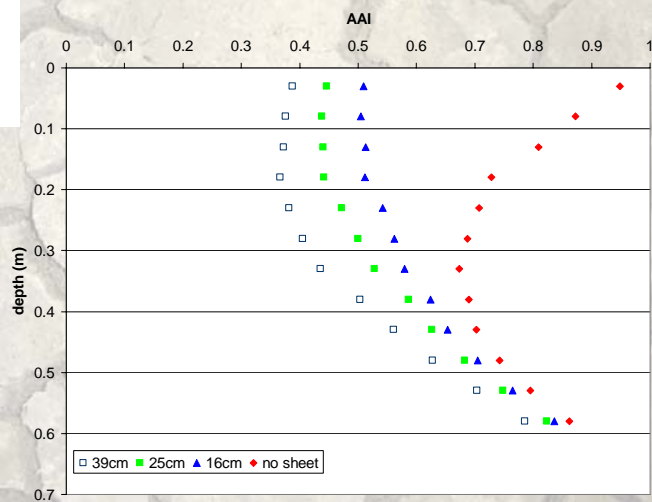
Sand filled lysimeter – sheet in part of plane:

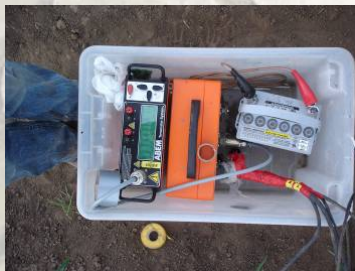
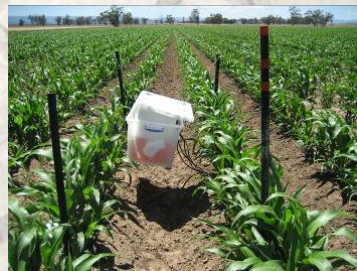
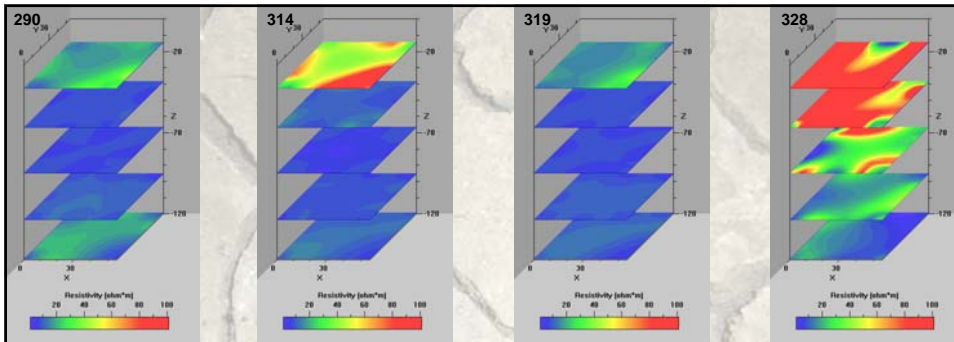
Installation of resistivity probes (1-2.11.2007)

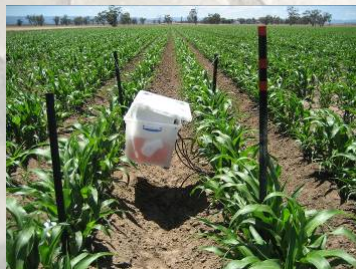
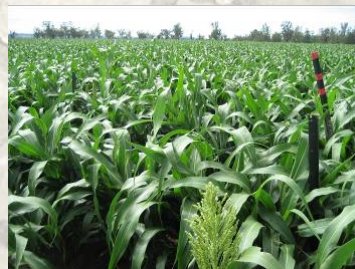
Field trial Nov 2007- Jan 2008
